**INSPECTION REPORT
ASBESTOS
EVERETT, WASHINGTON P.D.F.
8120 HARDESON ROAD
EVERETT, WA 98201-9998**

**UNITED STATES POSTAL SERVICE
ASBESTOS SURVEY**

USER AGENCY: United States Postal Service
FACILITY NAME: Everett, Washington P.D.F.
FINANCE/SUB #: 542774/G03
FACILITY ADDRESS: 8120 Hardeson Road
Everett, WA 98201-9998

FACILITY TELEPHONE #: (425) 355-7788
USPS SITE CONTACT: Mr. James Guffy
DATE OF SURVEY: 07/22/1997

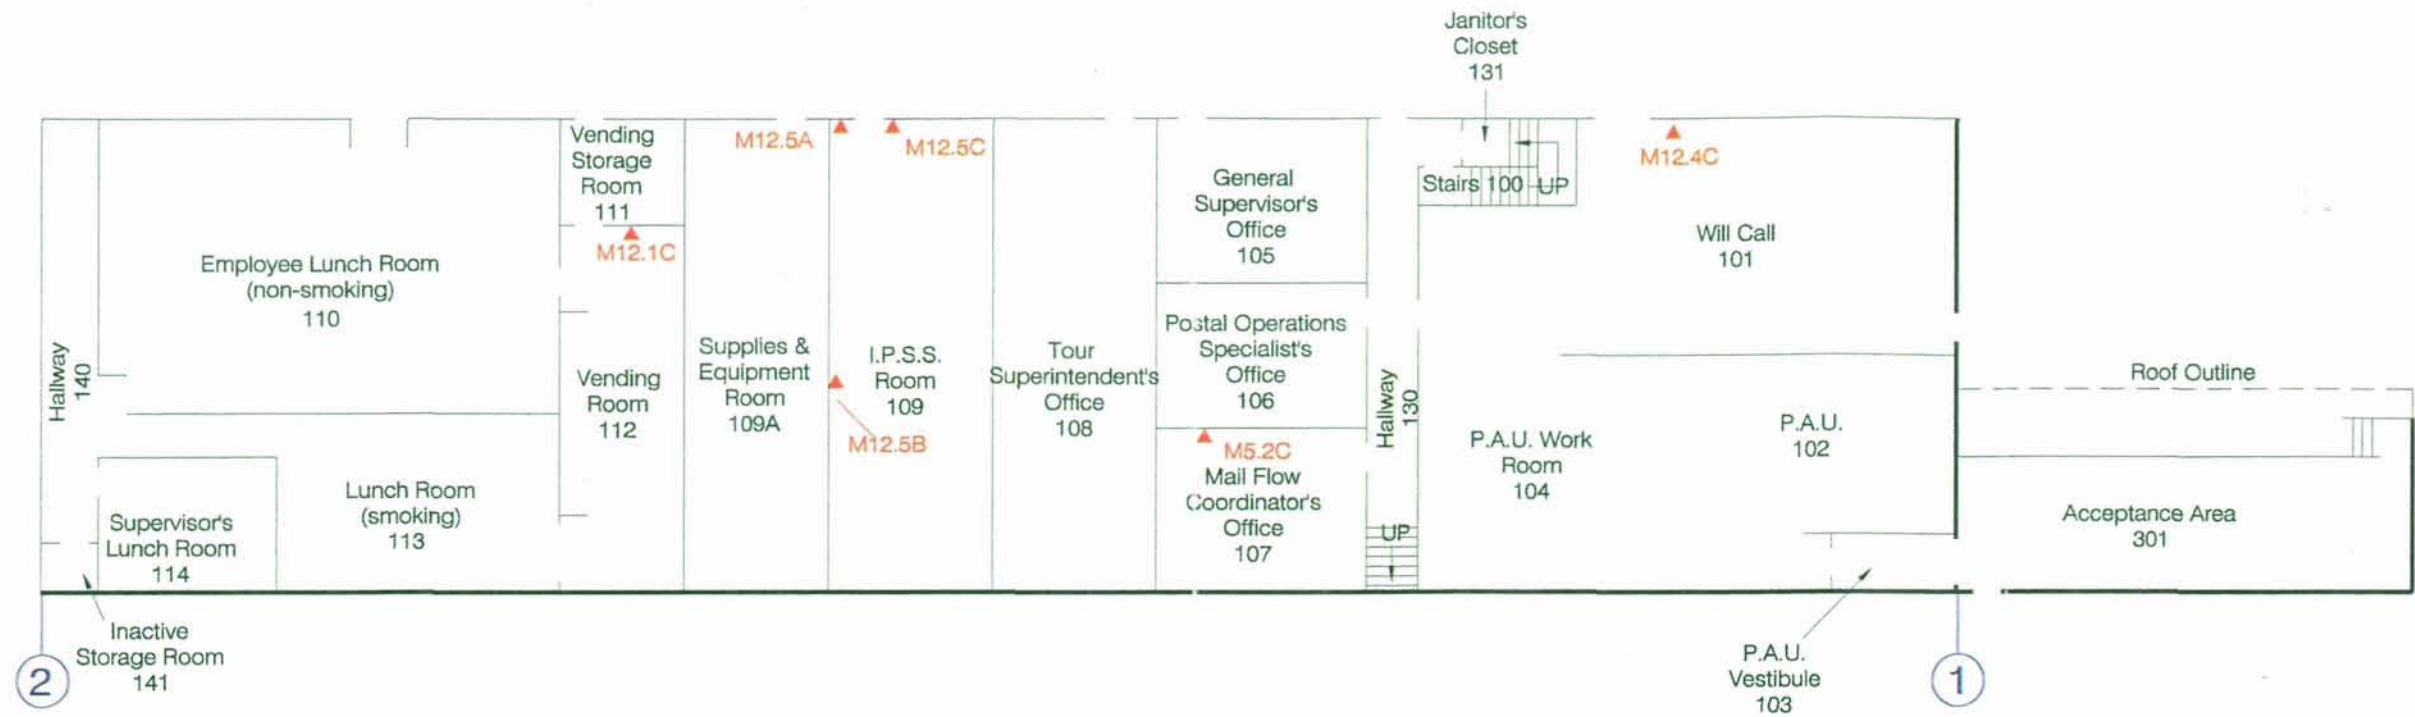
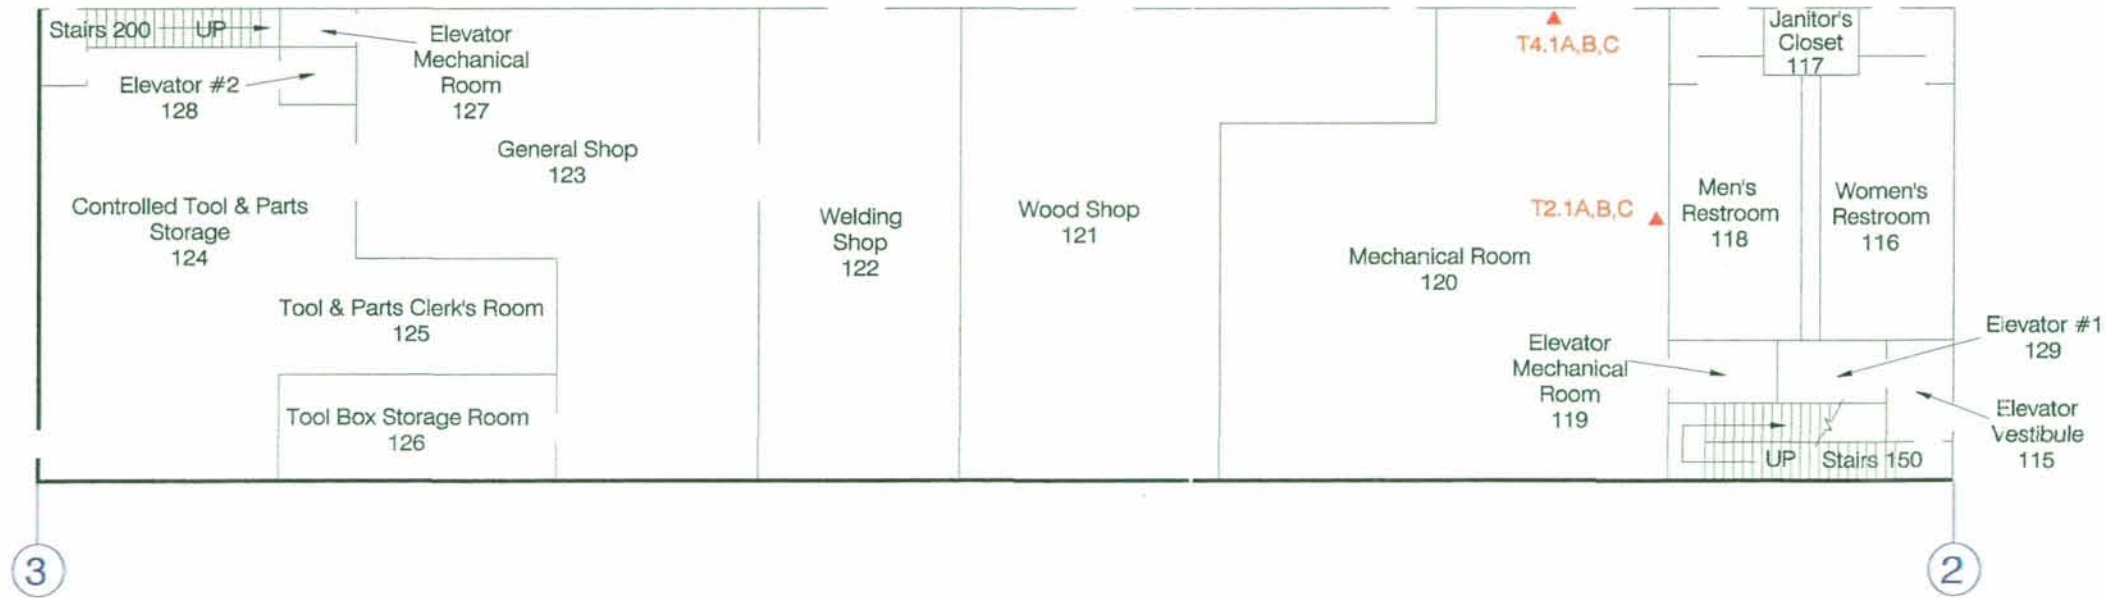
Contract No.: 072976-95-B-0004	ACBM Homogenous Area Locations
Work Order No.: 767.00	U.S. Postal Service - Asbestos Survey
Finance No.: 542774/G03	P.D.F, First Floor, Everett, Washington
Date: August 1997	FIGURE C.2-A

▲ Suspect ACBM Sample Location
(No ACBMs Detected)

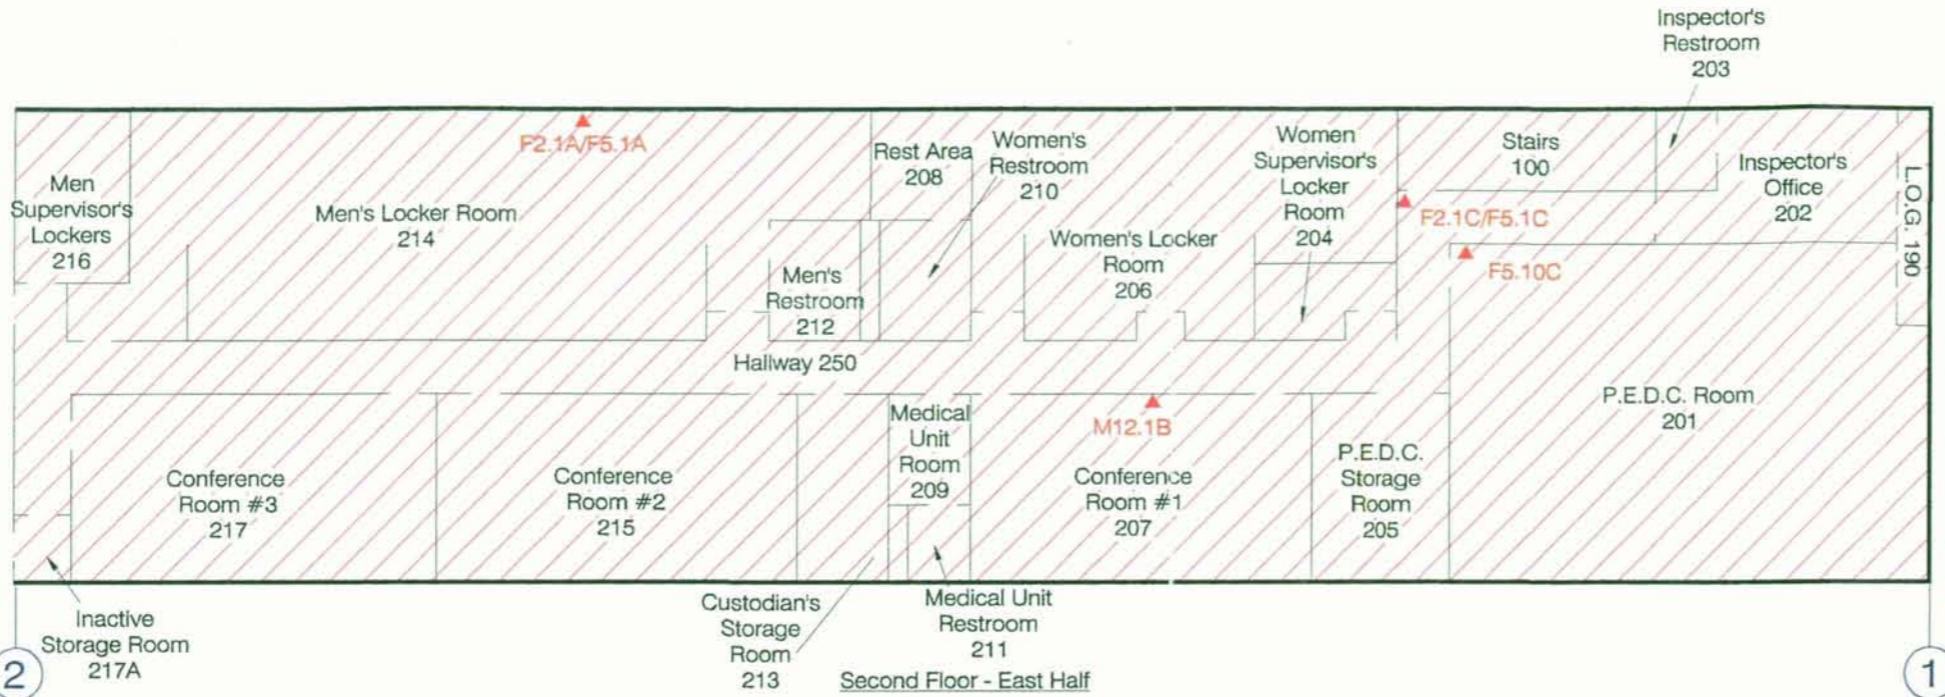
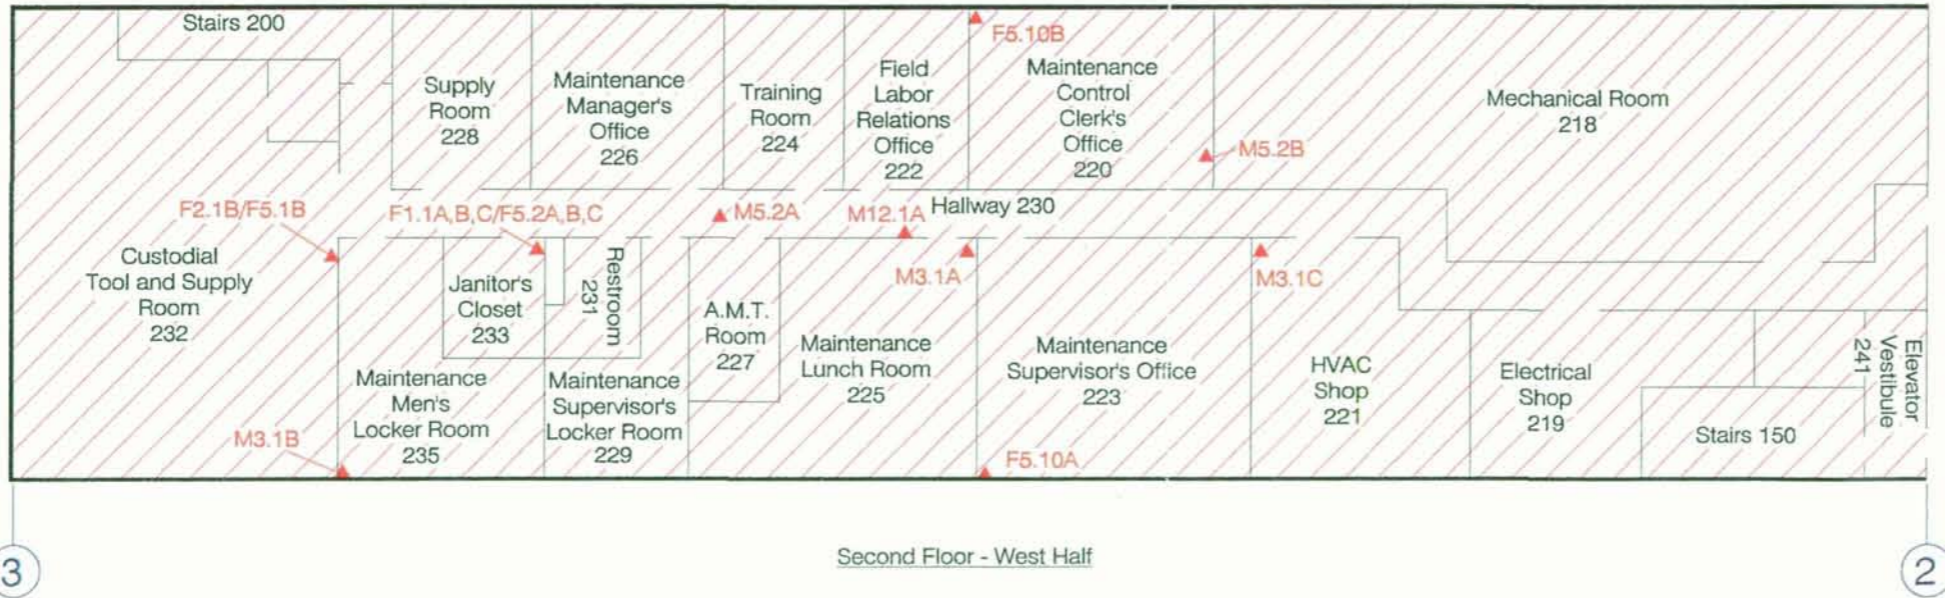
Contract No.: 072976-95-B-0004	ACBM Homogenous Area Locations
Work Order No.: 767.00	U.S. Postal Service - Asbestos Survey
Finance No.: 542774/G03	P.D.F, Second Floor, Everett, Washington
Date: August 1997	FIGURE C.2-B

- ▲ Suspect ACBM Sample Location
- ▨ ACBM (roof - assumed positive)

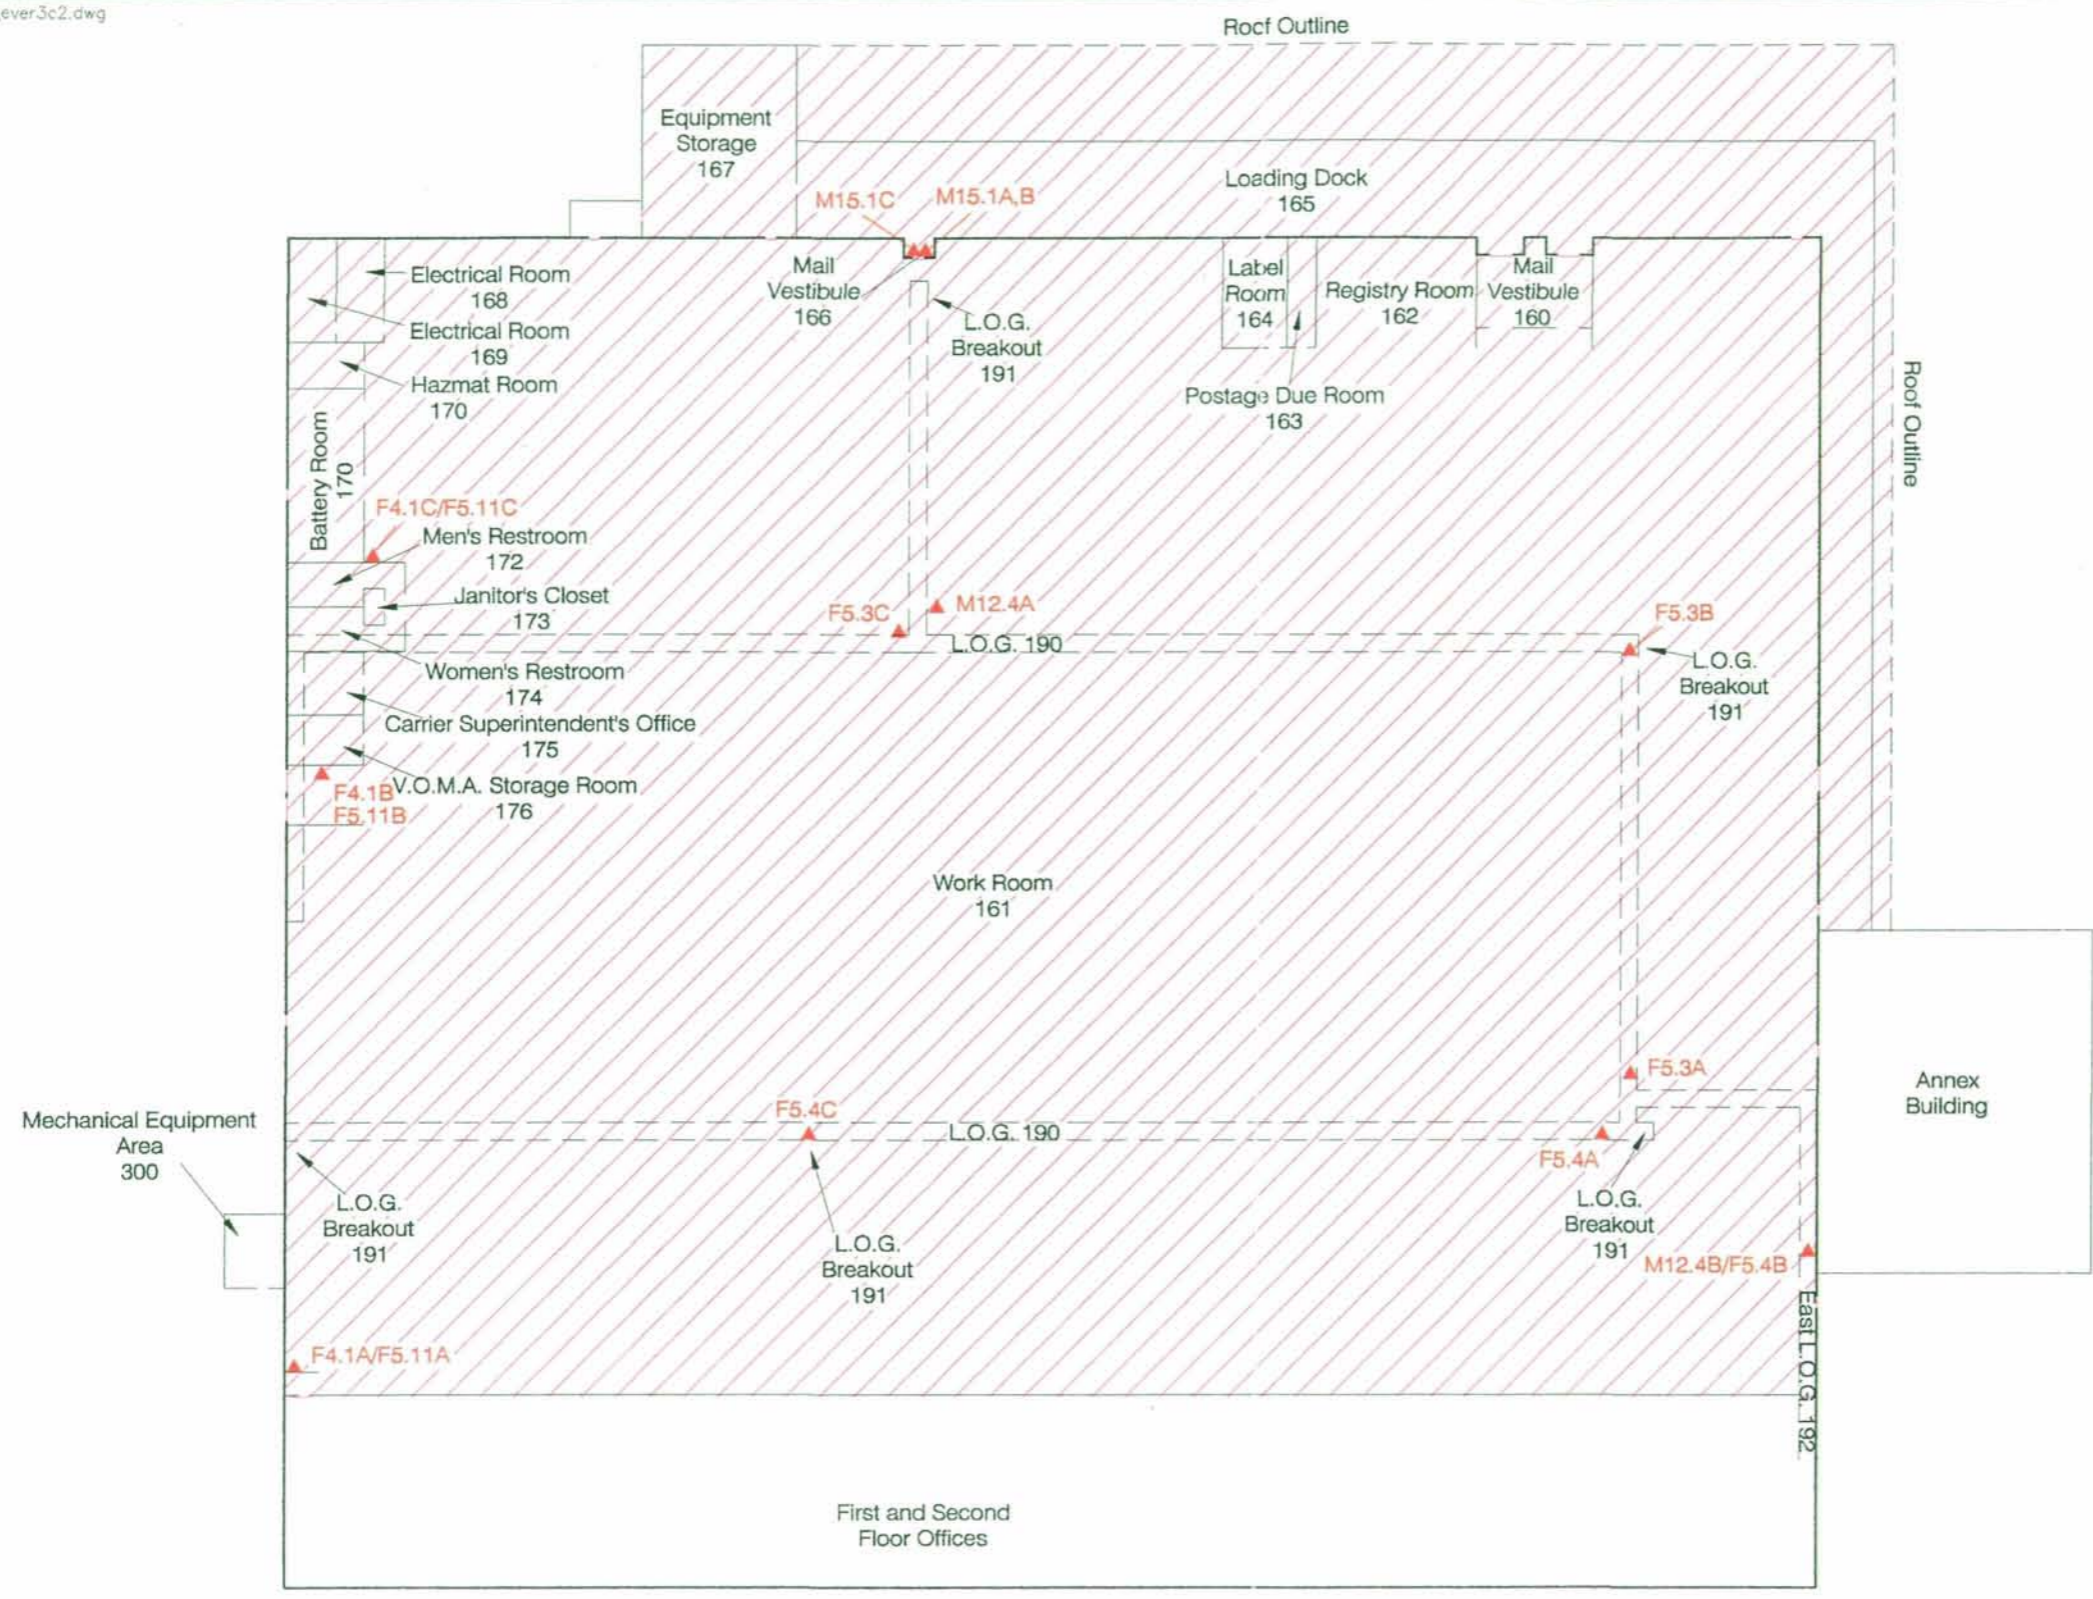
Contract No.: 072976-95-B-0004	ACBM Homogenous Area Locations
Work Order No.: 767.00	U.S. Postal Service - Asbestos Survey
Finance No.: 542774/G03	PDF, Main Work Area, Everett, Washington
Date: August 1997	FIGURE C.2-C

The roofing system of the facility was not sampled. It was observed to be in good condition and its integrity was not compromised by sampling. The roofing materials are assumed to be ACM. Maxim also recommends that prior to disturbance, removal or disposal of the roofing system that samples be collected and analyzed for asbestos content.

▲ Suspect ACBM Sample Location
 ▨ ACBM (roof - assumed positive)

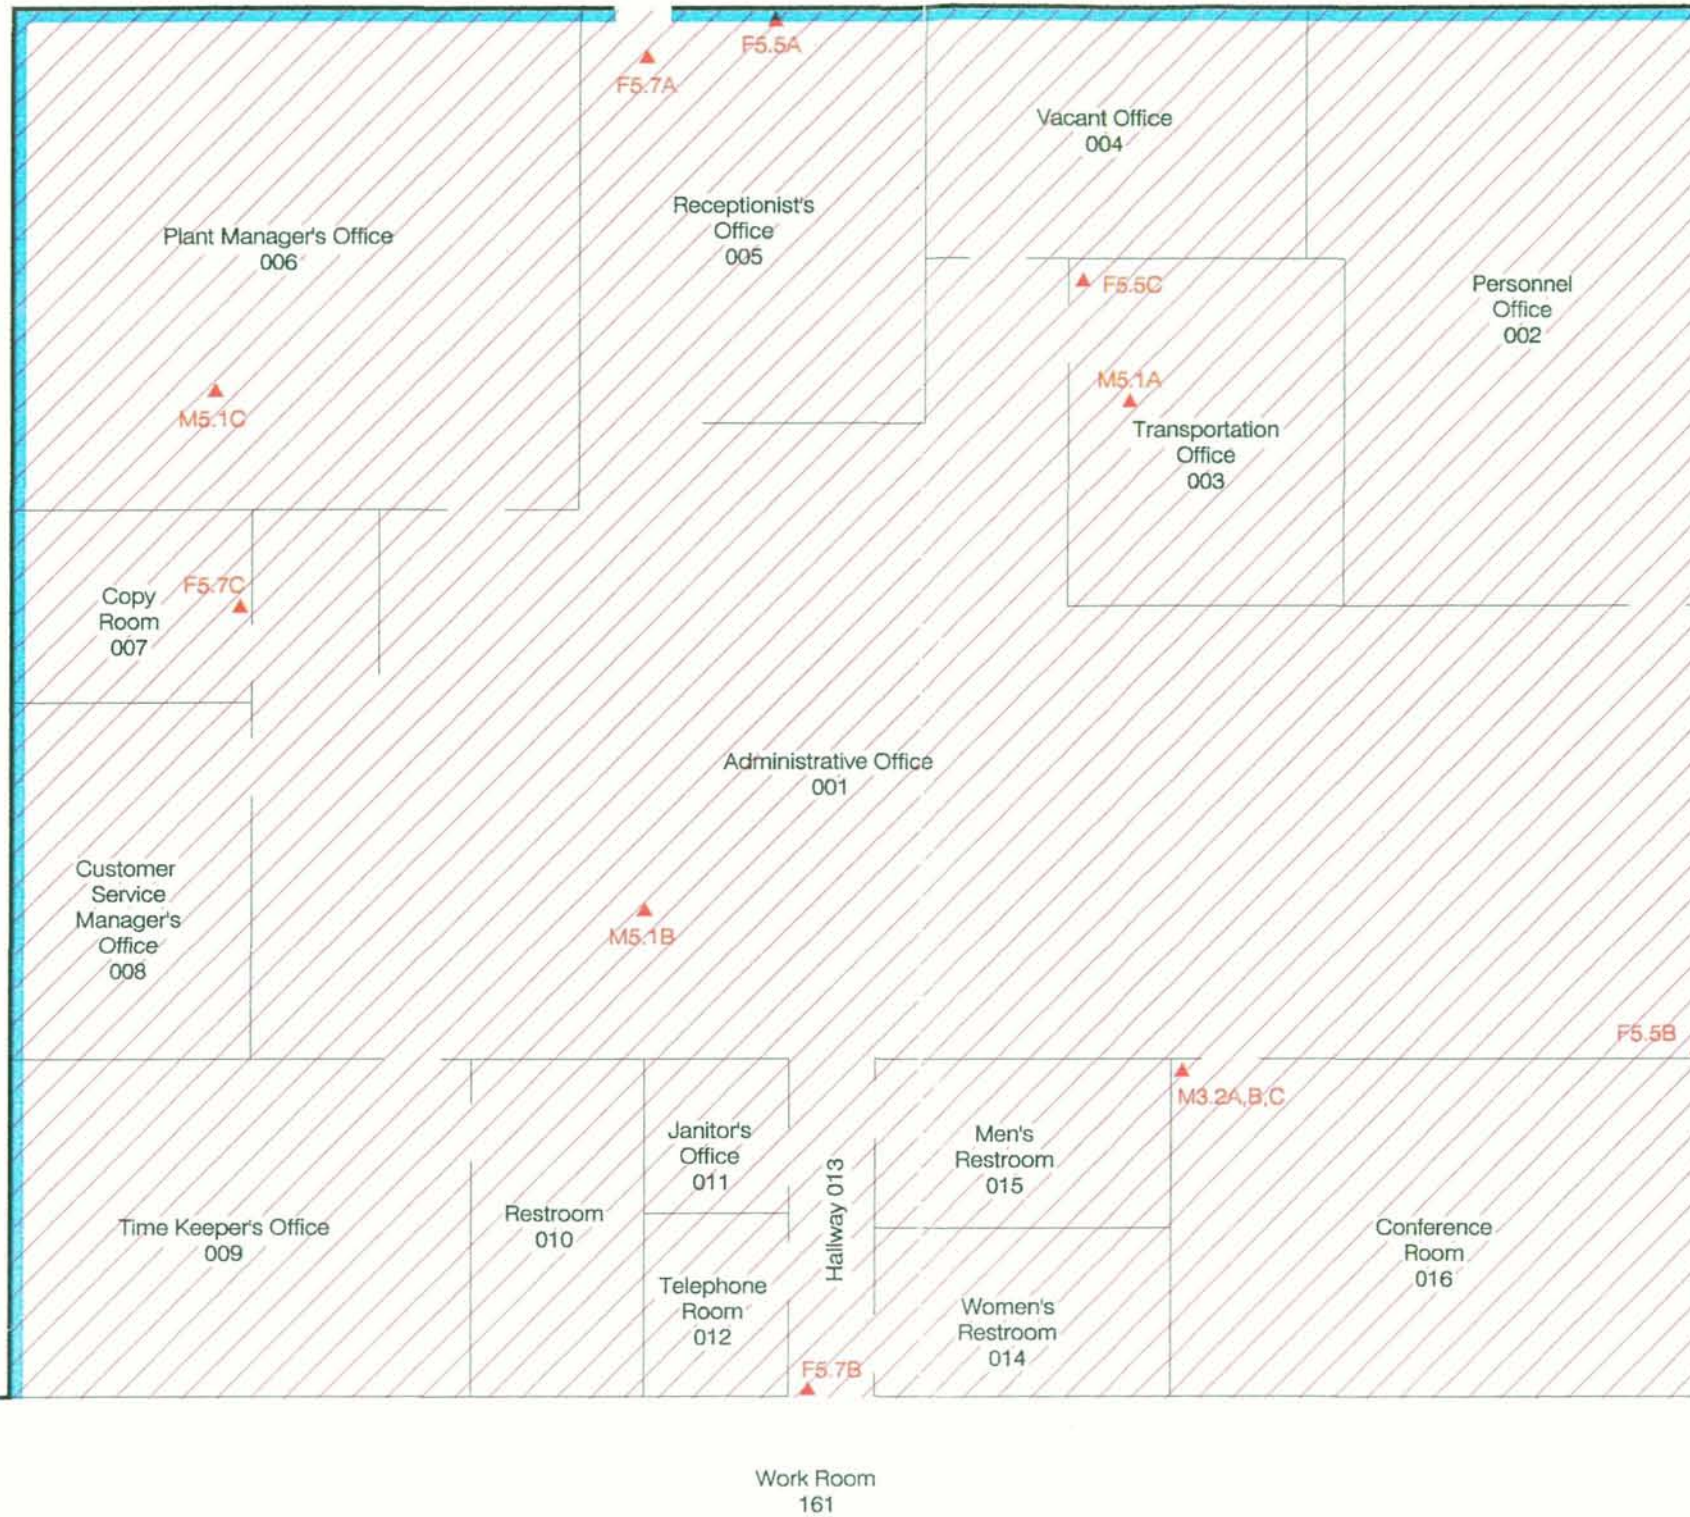
Contract No.: 072976-95-B-0004	ACBM Homogenous Area Locations
Work Order No.: 767.00	U.S. Postal Service - Asbestos Survey
Finance No.: 542744/G03	PDF, Annex, Everett, Washington
Date: August 1997	FIGURE C.2-D

- ▲ Suspect ACBM Sample Location
- ACBM (transite panels - assumed positive)
- ACBM (roof - assumed positive)

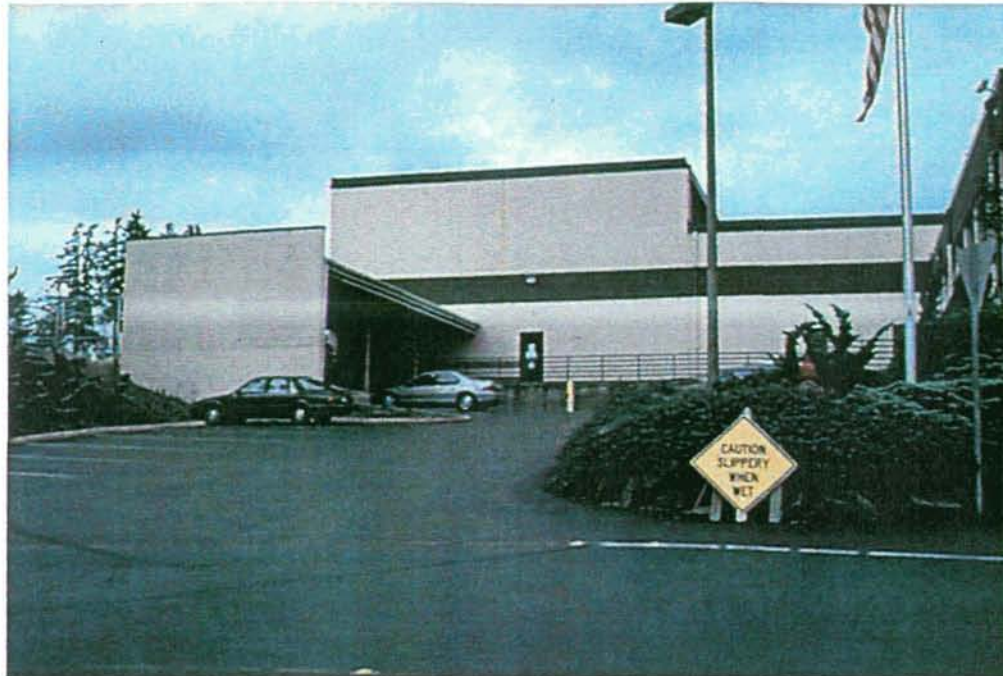
PHOTO #1 - SOUTHEAST SIDE VIEW OF FACILITY

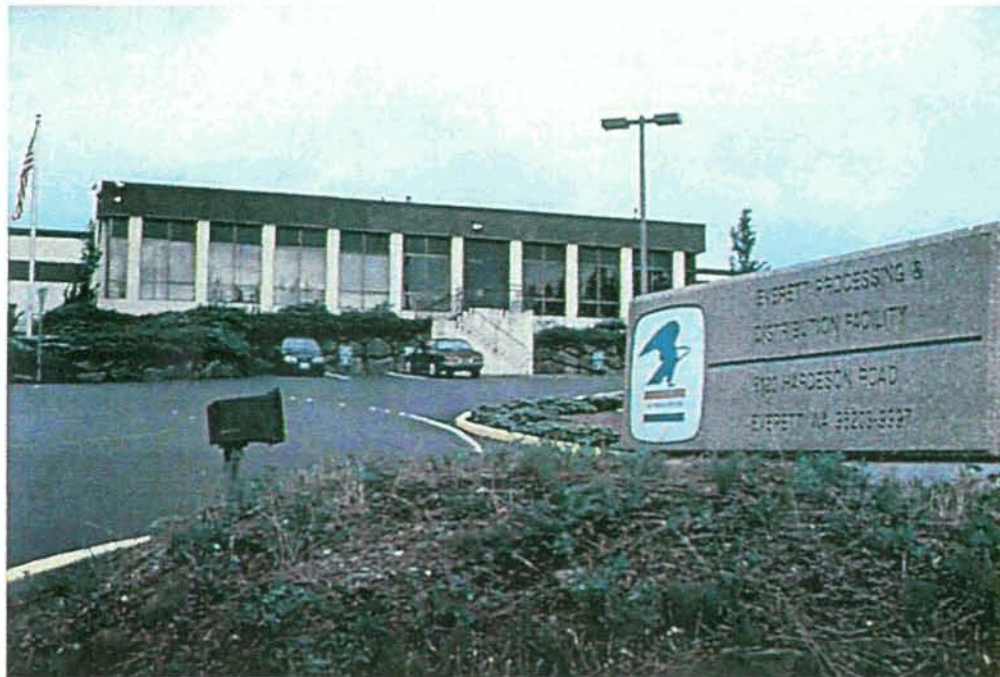
1st	002	Offices/Comp. Rooms	M	Transite	144	Yes	No	None Taken	1b	Decorative Panel - Assumed Positive
1st	002	Offices/Comp. Rooms	M	Wallboard/Taping Material	0	No	No	M3.1A,B,C	0	Walls
1st	003	Offices/Comp. Rooms	F	Mastic under Floor Tile/etc.	0	No	No	F5.5A,B,C	0	Mastic Under Blue/Gray/Rust Carpet
1st	003	Offices/Comp. Rooms	M	Ceiling Panels	0	No	No	M5.1A,B,C	0	2' x 4' White Large Pocked Ceiling Panel
1st	003	Offices/Comp. Rooms	M	Wallboard/Taping Material	0	No	No	M3.1A,B,C	0	Walls
1st	004	Offices/Comp. Rooms	M	Ceiling Panels	0	No	No	M5.1A,B,C	0	2' x 4' White Large Pocked Ceiling Panel
1st	004	Offices/Comp. Rooms	M	Transite	48	Yes	No	None Taken	1b	Decorative Panel - Assumed Positive

PHOTO #2 - EAST SIDE VIEW OF FACILITY WITH TRANSITE PANELS ABOVE WINDOWS

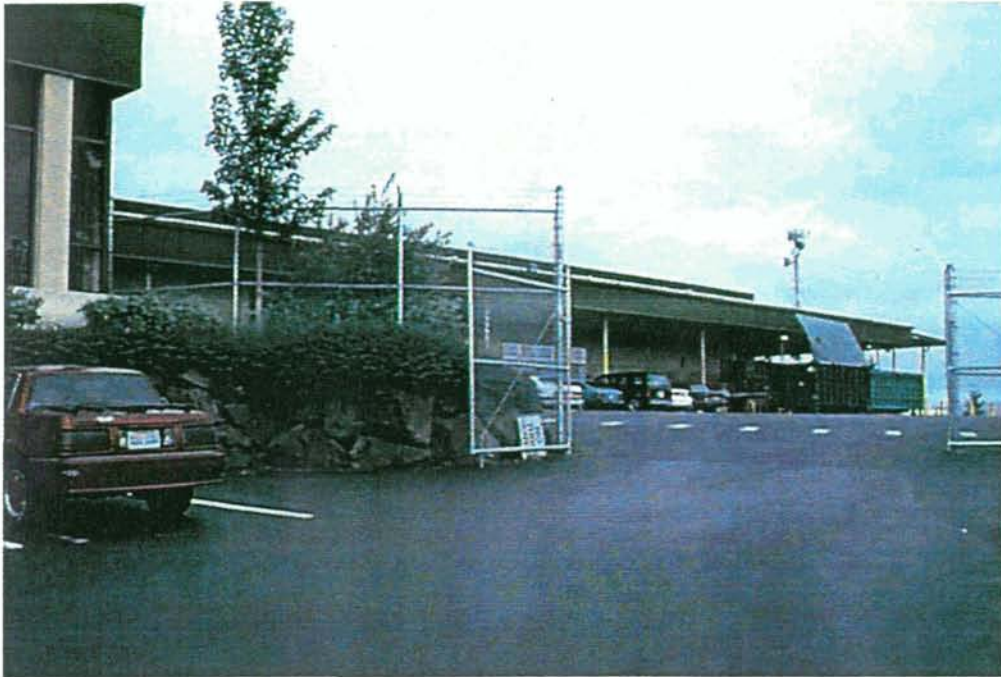
PHOTO #3 - NORTHEAST SIDE VIEW OF FACILITY

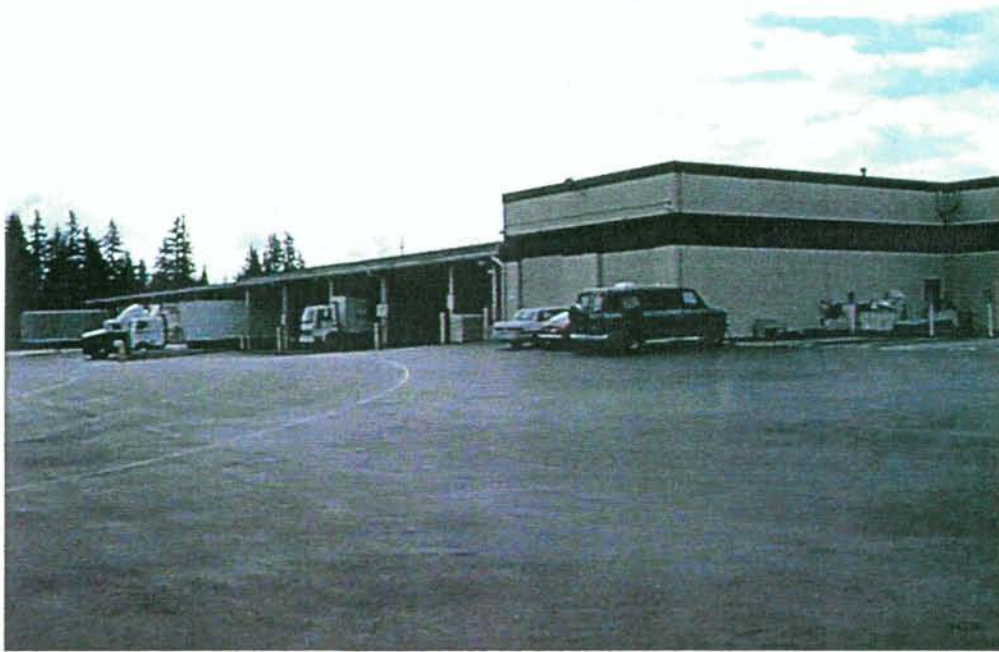
PHOTO #4 - NORTH SIDE VIEW OF FACILITY

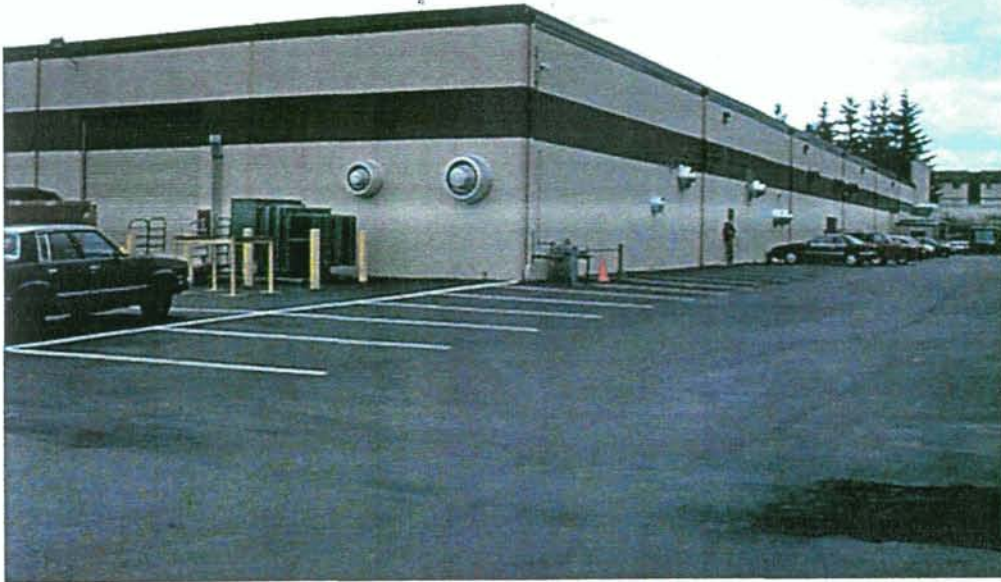
PHOTO #5 - WEST SIDE VIEW OF FACILITY

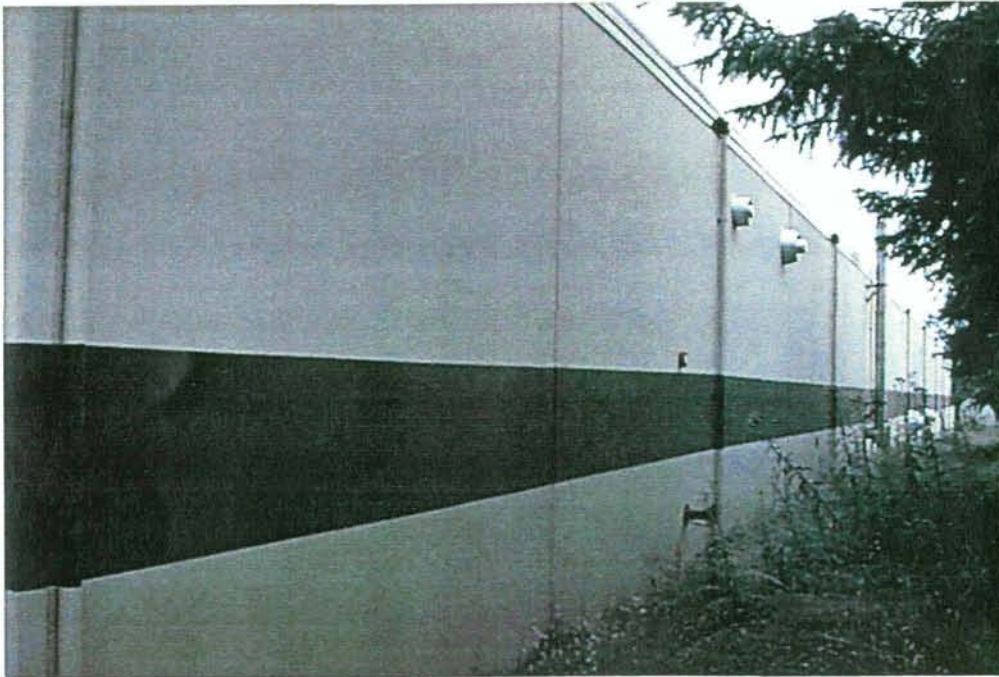
PHOTO #6 - SOUTH SIDE VIEW OF FACILITY
