**INSPECTION REPORT
ASBESTOS
SEATTLE, WA - RIVERTON HEIGHTS STATION
15250 32ND AVENUE S
SEATAC, WA 98188-9998**

**UNITED STATES POSTAL SERVICE
ASBESTOS SURVEY**

USER AGENCY: United States Postal Service
FACILITY NAME: Seattle, WA - Riverton Heights Station Post Office
FINANCE/SUB #: 547616/615
FACILITY ADDRESS: 15250 32nd Avenue S
P.O. Box 9998
SeaTac, WA 98188-9998
FACILITY TELEPHONE #: (206) 242-0022
USPS SITE CONTACT: Mr. Bill Chambers
DATE OF SURVEY: 05/13/1997
CONSULTING FIRM NAME: Maxim Technologies, Inc.
CONSULTING FIRM ADDRESS: 1610 B Street
P.O. Box 4699
Helena, MT 59604-4699
CONSULTING FIRM PHONE #: (406) 443-5210
CONTRACT NUMBER: 072976-95-B-0004
PROJECT NUMBER: 5609702640.A1
WORK ORDER NUMBER: 742.00
LABORATORY ADDRESS: Maxim Technologies, Inc.
600 South 25th Street
Billings, MT 59101-4549
LABORATORY PHONE #: (406)248-9161

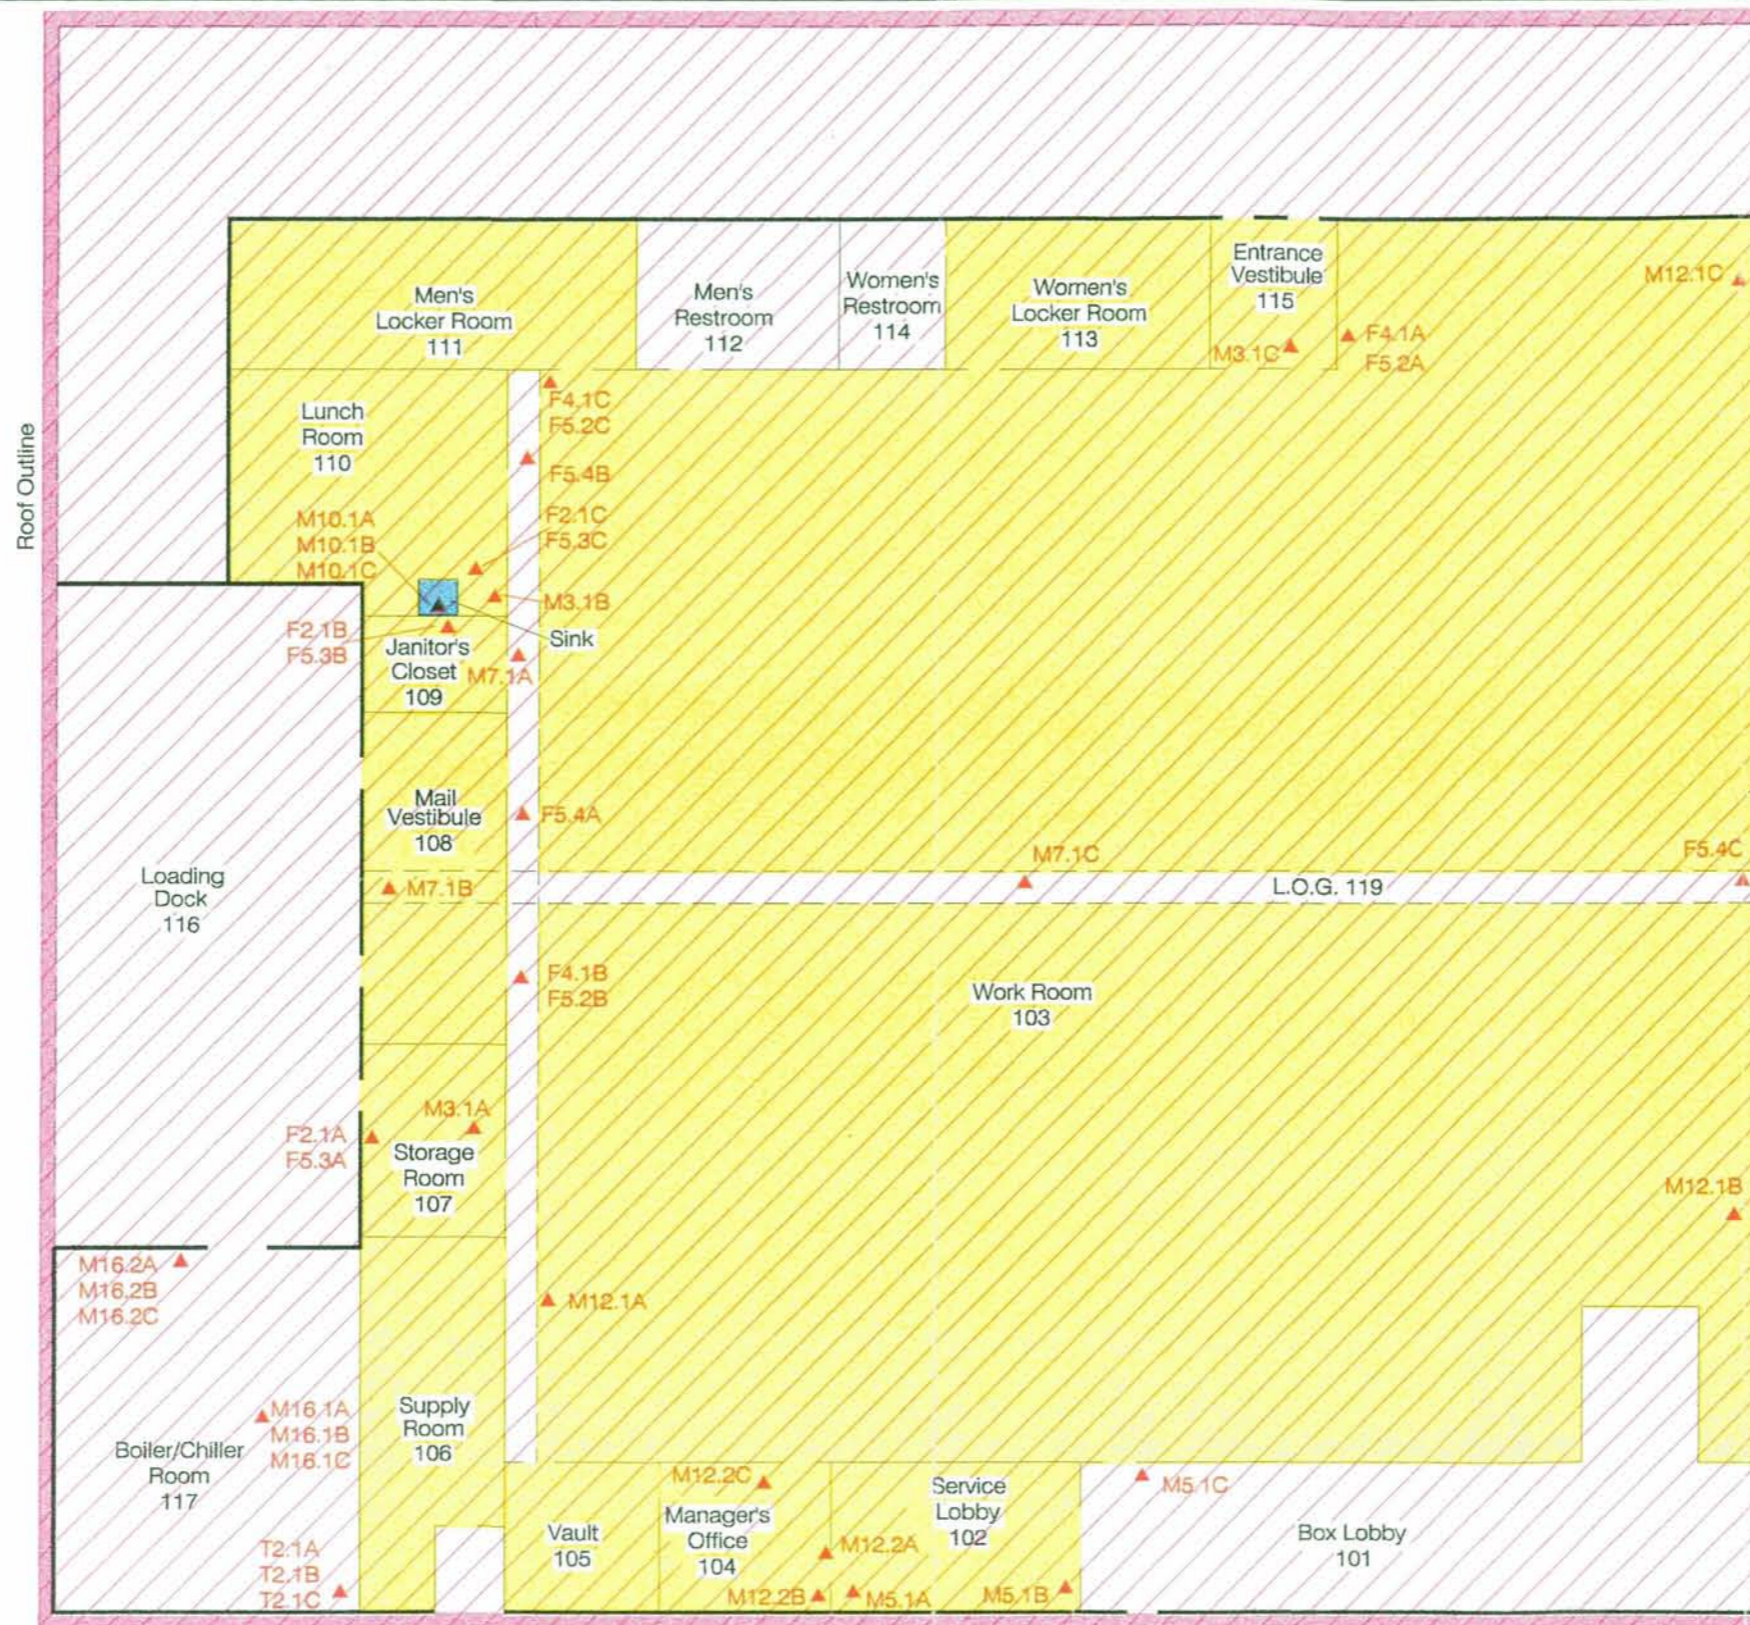
C.3. Homogeneous Material Summary By Functional Floor and Area Locations

- ACBM (floor tile and mastic)
- ACBM (undercoat on sink)
- ACBM (roof - assumed positive)
- ACBM (stucco - assumed positive)
- Suspect ACBM Sample Location

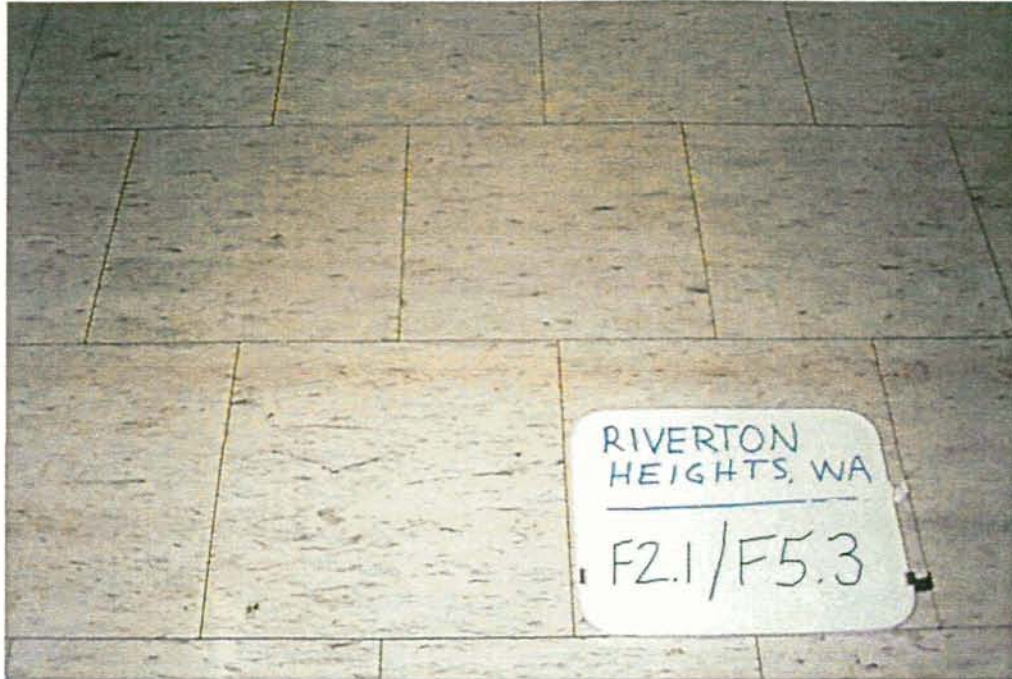
PHOTO #3 - 12"x12" CREAM FLOOR TILE (F2.1) AND MASTIC (F5.3)

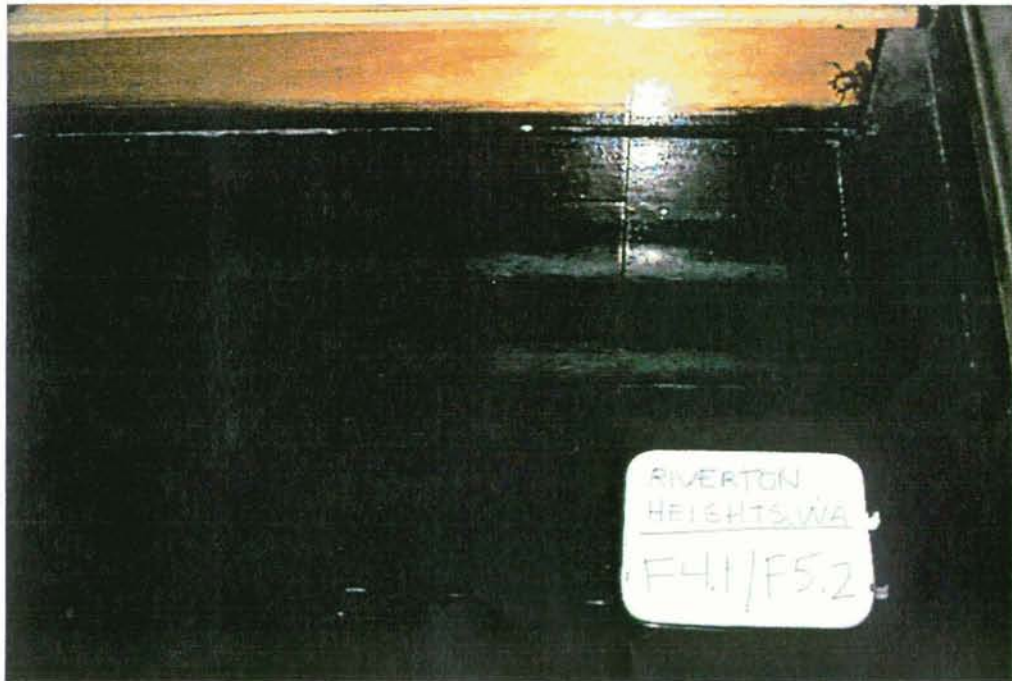
PHOTO #4 - 12"x24" BLACK FLOOR PLANK (F4.1)
AND MASTIC (F5.2)

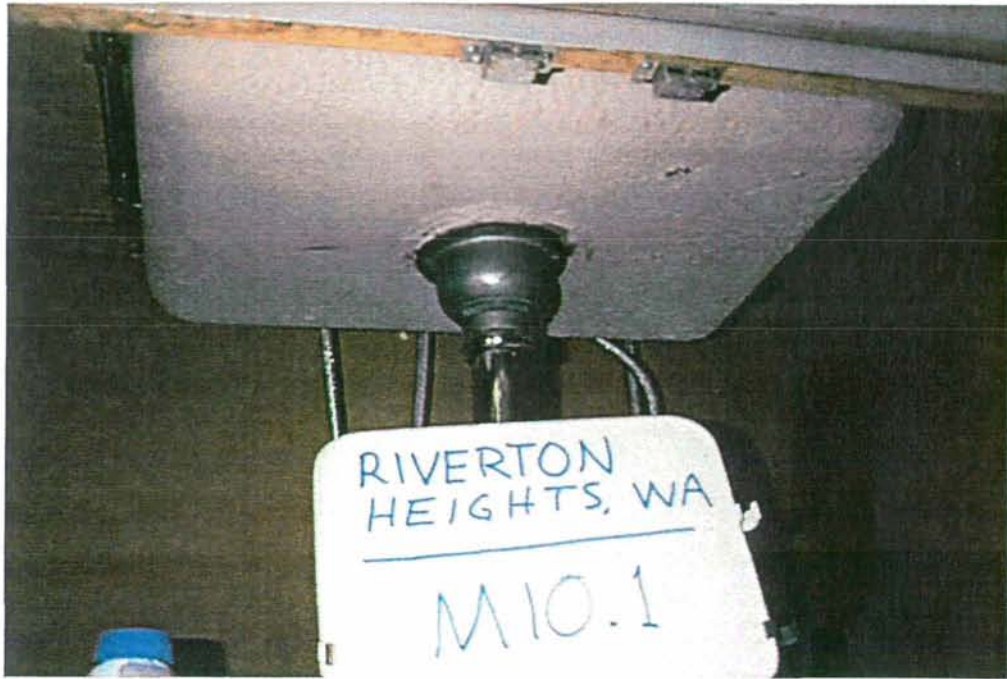
PHOTO #5 - UNDERCOATING ON SINK (M10.1)
