**INSPECTION REPORT
ASBESTOS
OLYMPIA, WA
LACEY BRANCH POST OFFICE
5815 LACEY BLVD.
LACEY, WA 98503-9998**

**UNITED STATES POSTAL SERVICE
ASBESTOS SURVEY**

USER AGENCY: United States Postal Service
FACILITY NAME: Olympia, WA - Lacey Branch Post Office
FINANCE/SUB #: 546146-004
FACILITY ADDRESS: 5815 Lacey Blvd.

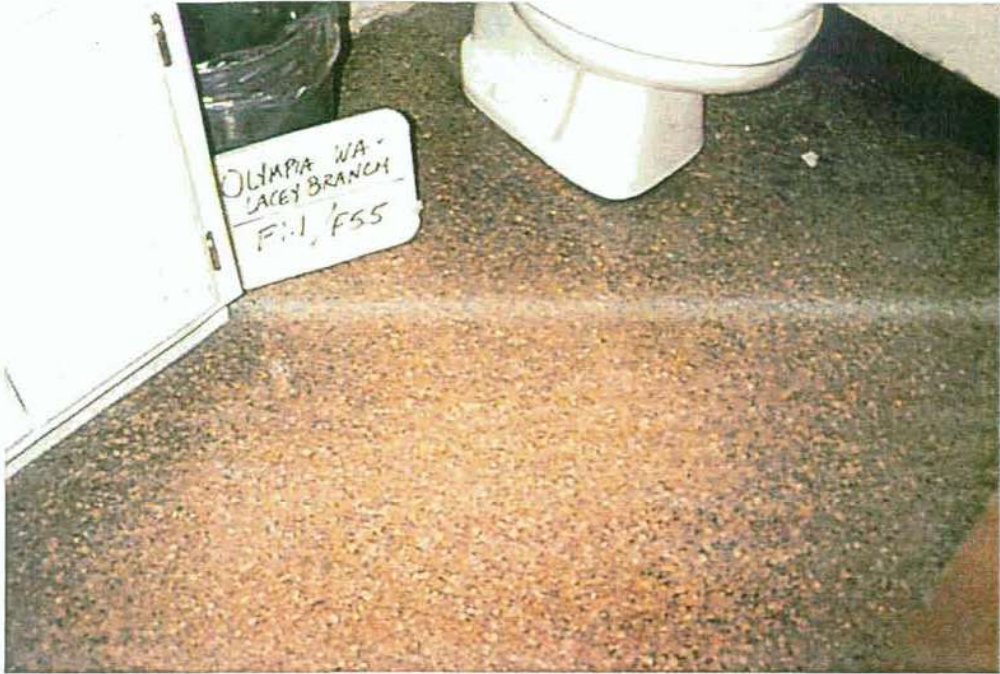
PHOTO #3 - GOLD SHEET VINYL (F1.1) AND MASTIC (F5.5)

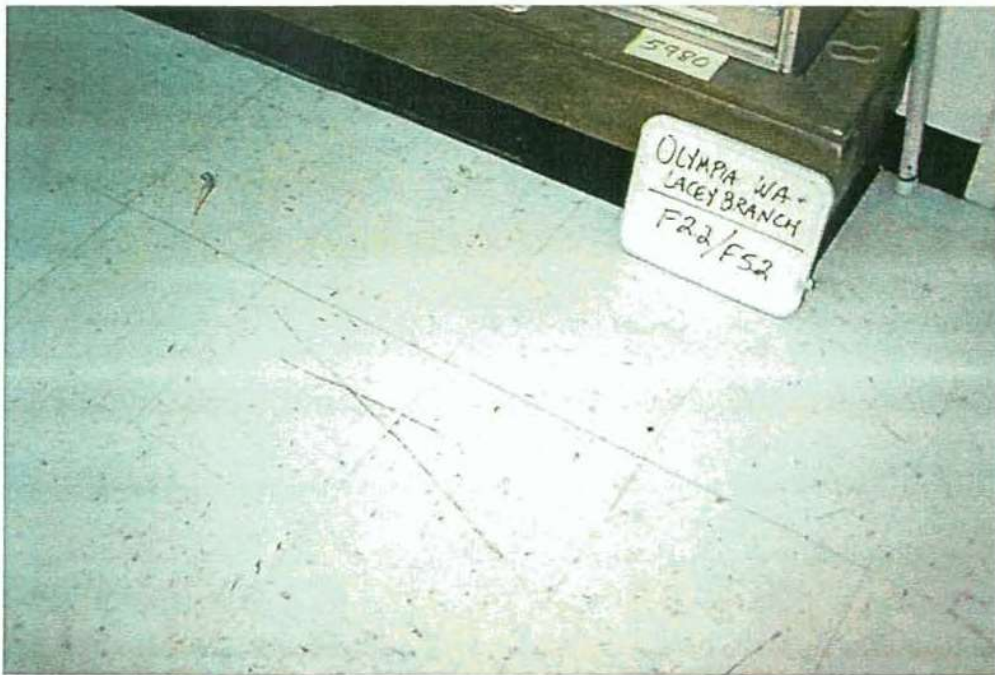
PHOTO #4 - 12"x12" BEIGE WITH BROWN SPOTS FLOOR TILE (F2.2) AND MASTIC (F5.2)

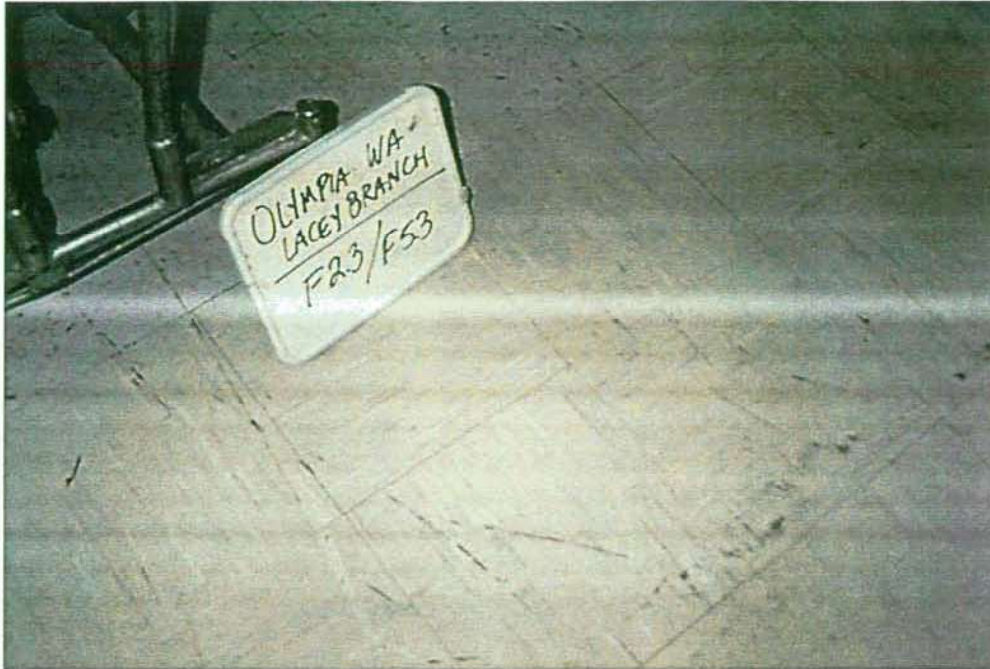
PHOTO #5 - MASTIC UNDER 12"x12"

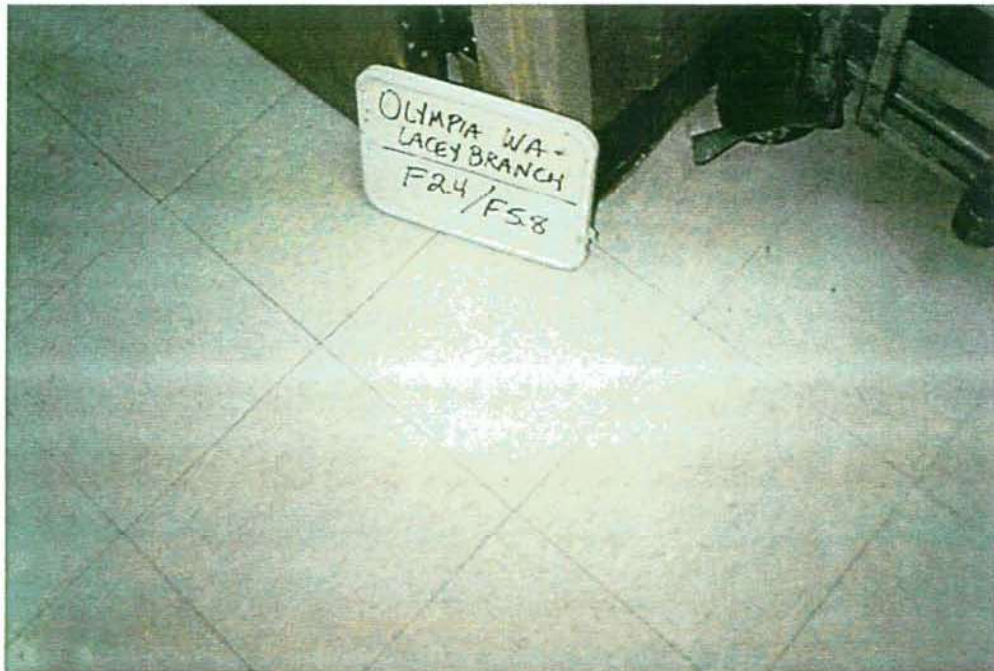
PHOTO #6 - MASTIC UNDER 12"x12" BEIGE WITH LINES
FLOOR TILE (F5.8)

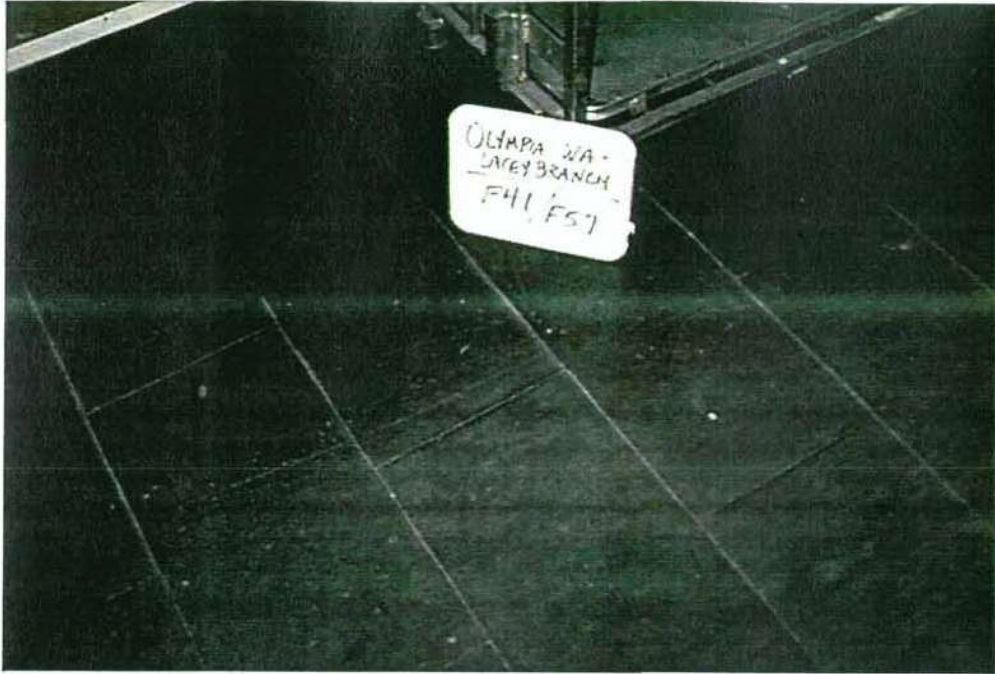
PHOTO #7 - MASTIC UNDER BLACK FLOOR PLANK (F5.7)

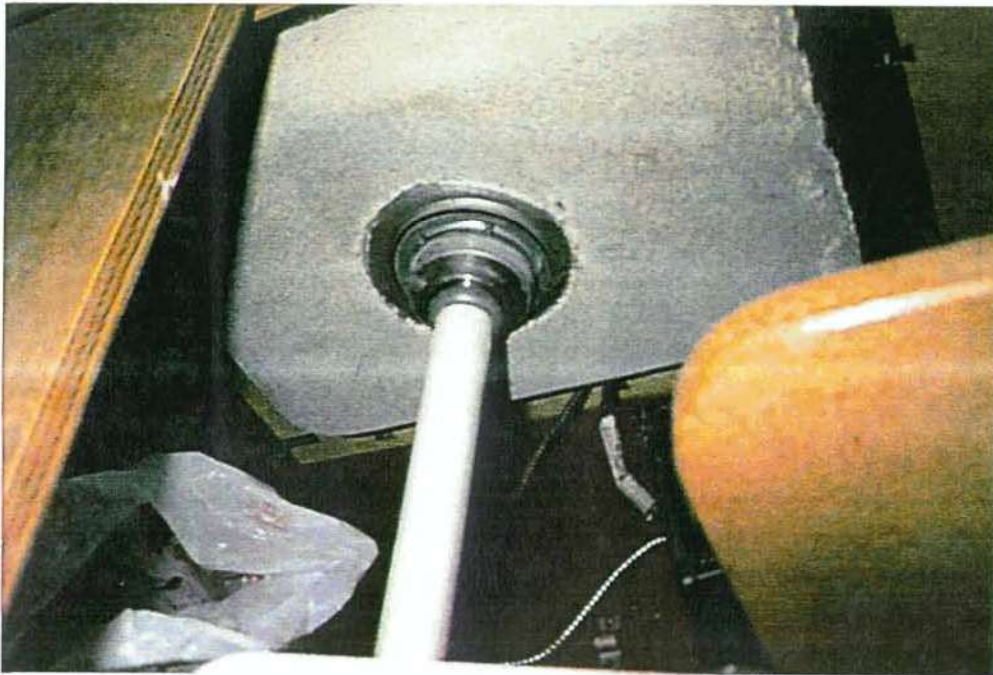
PHOTO #8 - SINK UNDER COATING (M10.1)
